RFP Item #22-195 13th Street Improvement Project and Telfair Street

#### ADDENDUM NO. 2

## REPORT OF PAVEMENT CONDITION SURVEY

#### PAVEMENT CONDITION SURVEY BROAD, GREEN, TELFAIR, 13TH, 9TH, 6TH AND 5TH STREETS AUGUSTA, GEORGIA

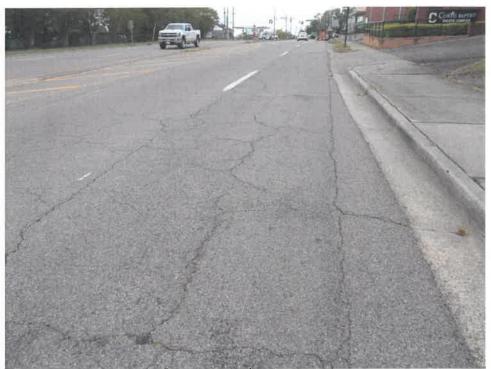
Photograph 29: Broad Street – View facing southeast of low severity block cracking near C-1.

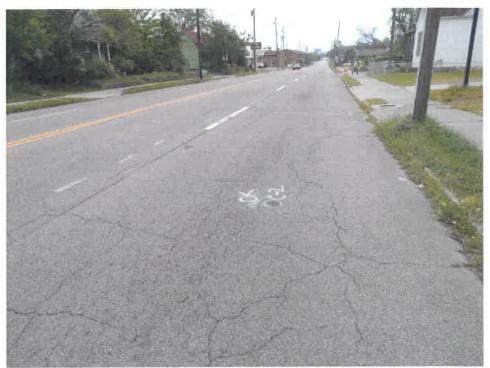
Photograph 30: Broad Street – View facing southeast of low severity longitudinal cracking near C-2.

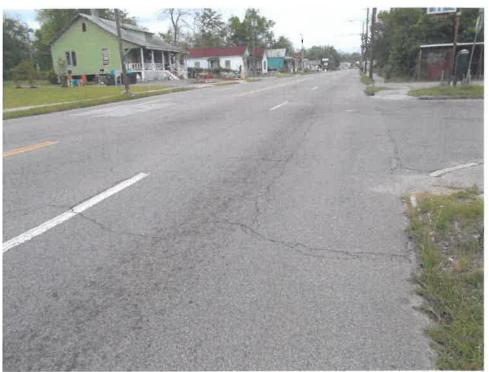
Photograph 31: Broad Street – View facing northwest of low severity longitudinal and transverse cracking and several medium severity patches at intersection of Curry Street.

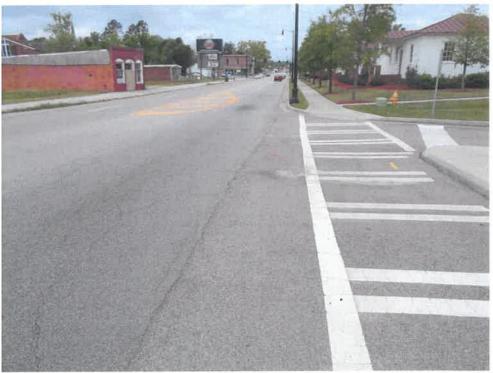
Photograph 32: Broad Street – View facing northwest of low severity longitudinal cracking in the vicinity of Core C3.

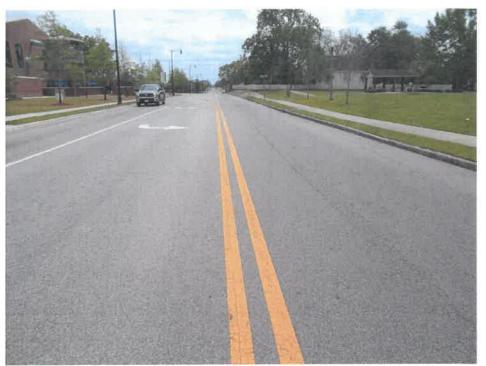
Photograph 33: Broad Street – View facing east of pavement in Good condition near intersection of Eve Street between Cores C1 and C2.

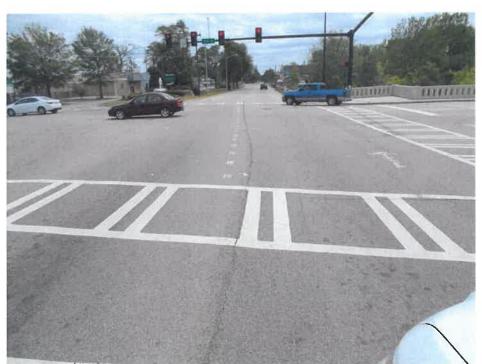
Photograph 34: Broad Street – View facing east of pavement in Good condition at intersection with 15th Street looking east.

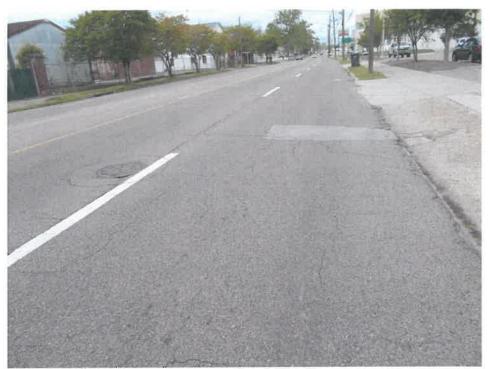
Photograph 35: Broad Street – View facing northwest of low severity longitudinal cracks and a medium severity patch near Core C4.

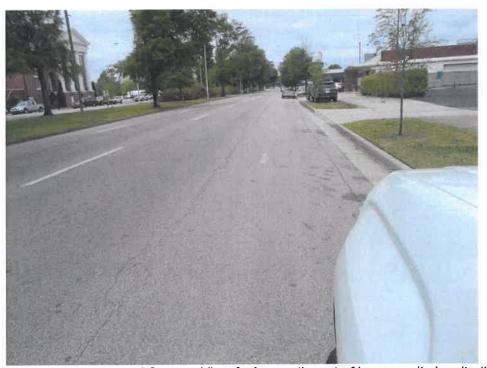
Photograph 36: Broad Street – View facing northwest of low severity longitudinal and joint cracks near Core C5.

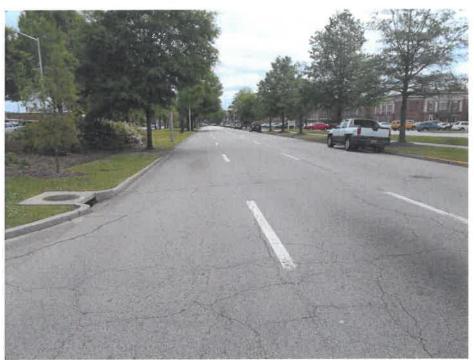
Photograph 37: Broad Street – View facing southeast of low severity block cracking near 14<sup>th</sup> Street.

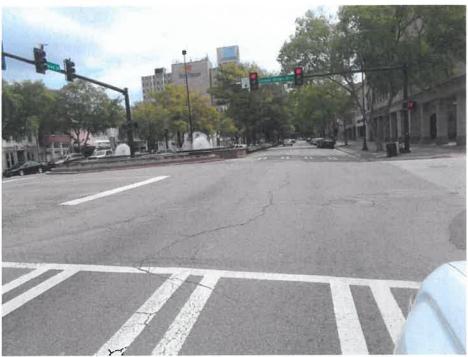
Photograph 38: Broad Street – View facing southeast of medium severity longitudinal cracking and low severity utility patch at intersection with James Brown Blvd near Core C-6.

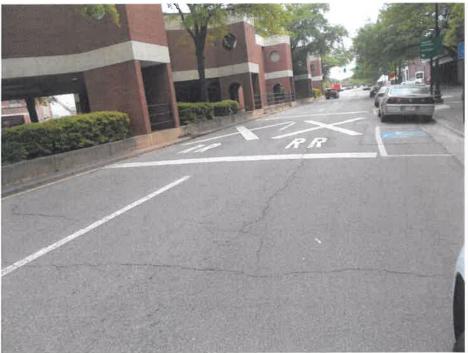
Photograph 39: Broad Street – View facing southeast between 6<sup>th</sup> Street and 7<sup>th</sup> Streets of low severity longitudinal and transverse.

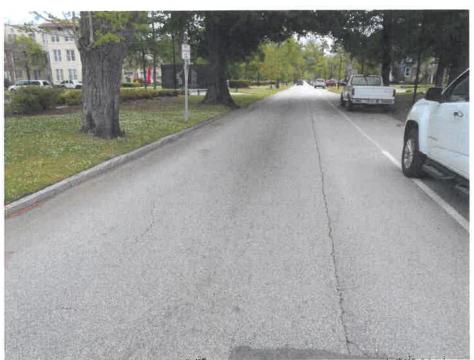
Photograph 40: Broad Street – View facing southeast of low severity weathering of pavement in Good condition near intersection with 4<sup>th</sup> Street.

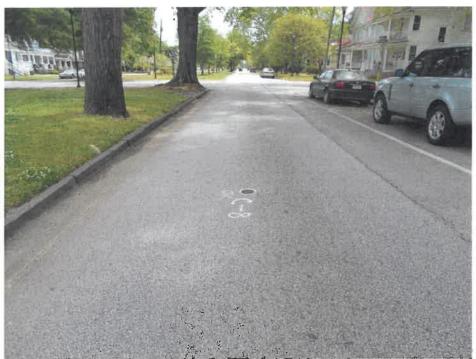
Photograph 41: Broad Street – View facing southeast of low severity weathering of pavement in Good condition near Core C8.

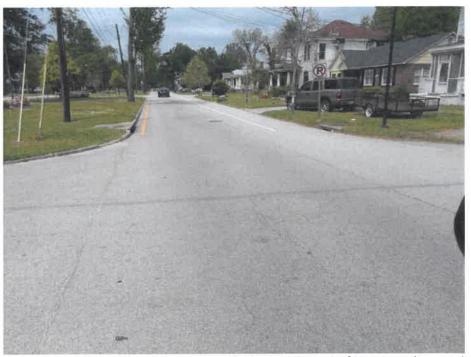
Photograph 42: Broad Street – View facing northwest of low severity weathering of pavement in Good condition at intersection of East Boundary Street.

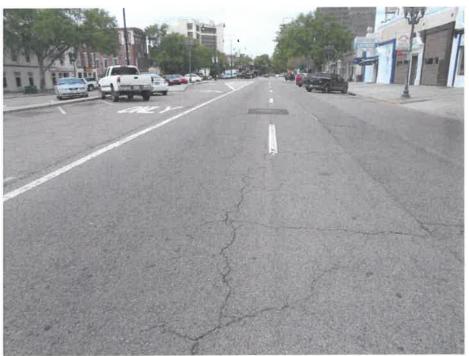
Photograph 43: Broad Street – View facing northwest of medium severity longitudinal and transverse cracking of pavement in Satisfactory condition near Core C7.

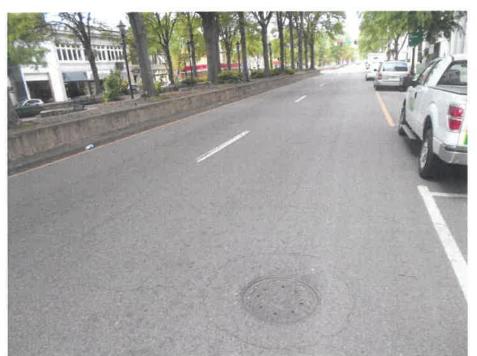
Photograph 44: Broad Street – View facing northwest approaching 8th Street of reflective cracking around manhole collar (typical).

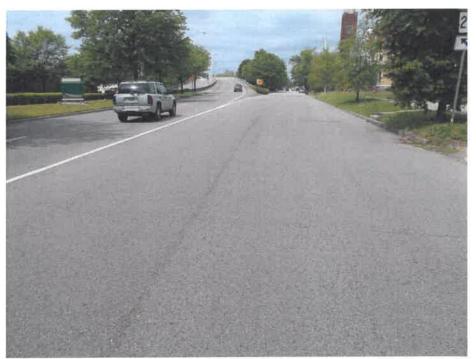
Photograph 45: Green Street – View facing northwest of pavement in Good condition near Core C9.

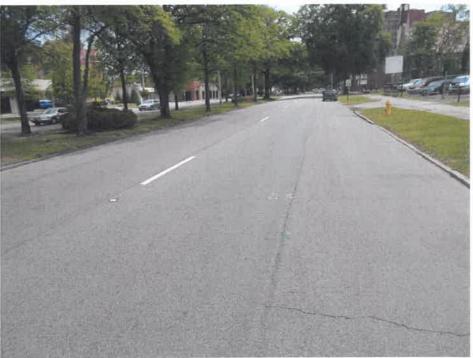
Photograph 46: Green Street – View facing southeast of single low severity transverse crack of pavement in Good condition between 11th Street and 12th Streets.

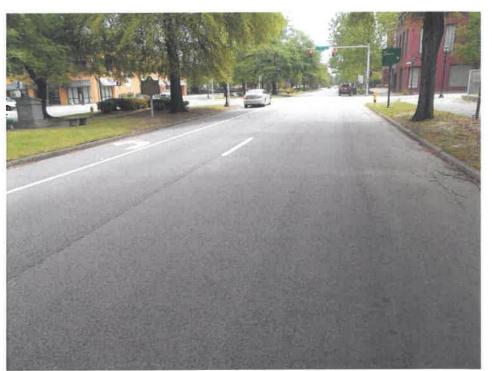
Photograph 47: Green Street – View facing southeast of pavement in Good condition near Core C10.

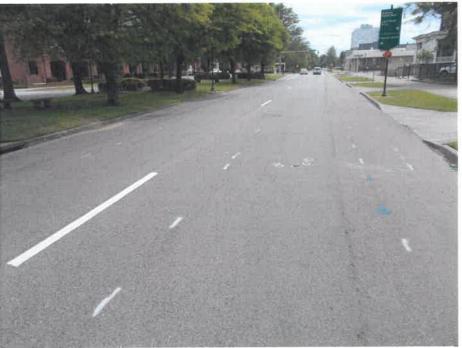
Photograph 48: Green Street – View facing southeast of pavement in Good condition near Core C10.

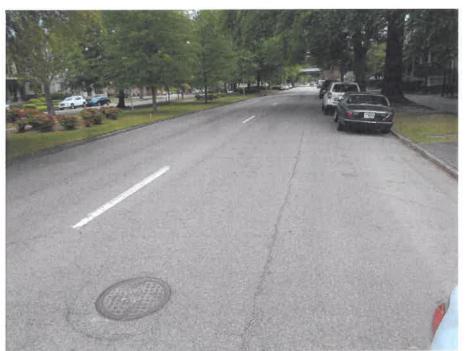
Photograph 49: Green Street – View facing southeast of pavement in Good condition near intersection with 5<sup>th</sup> Street.

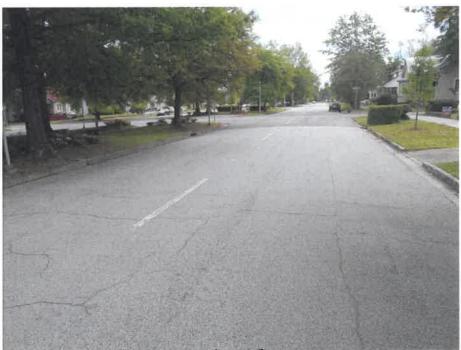
Photograph 50: Green Street – View facing southeast of low severity block cracking near Core C12.

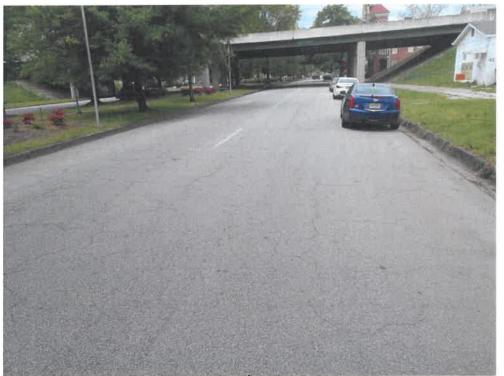
Photograph 51: Green Street – View facing northwest of low severity block cracking in pavement in Satisfactory condition near Core C11.

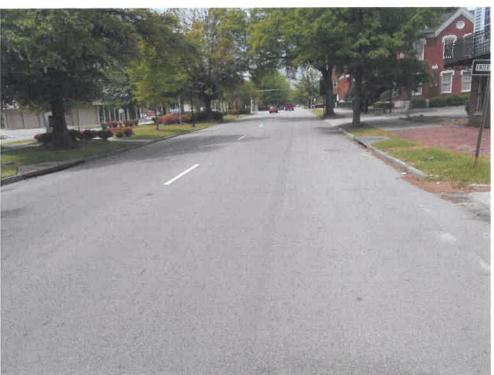
Photograph 52: Green Street – View facing northwest of pavement in Good condition between 6th Street and 7th Street.

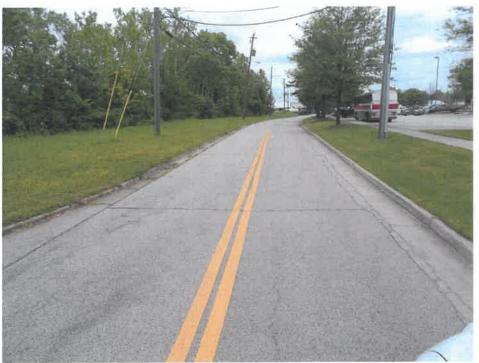
Photograph 53: Telfair Street – View facing northwest of low severity joint crack and medium severity weathering near intersection of Green Street.

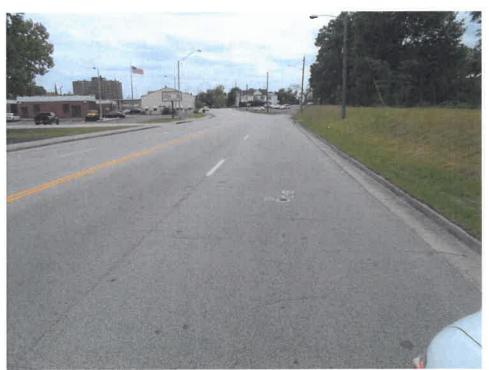
Photograph 54: Telfair Street – View facing southeast of pavement in Good condition near Core C13 looking.

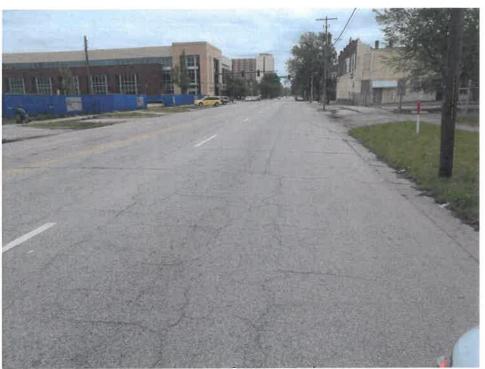
Photograph 55: Telfair Street – View facing southeast of low to medium severity block cracking near intersection with 9<sup>th</sup> Street.

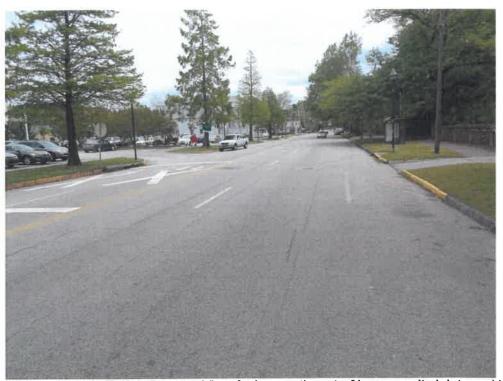
Photograph 56: Telfair Street – View facing southeast of low severity joint cracking in pavement between 6<sup>th</sup> Street and 5<sup>th</sup> Street.

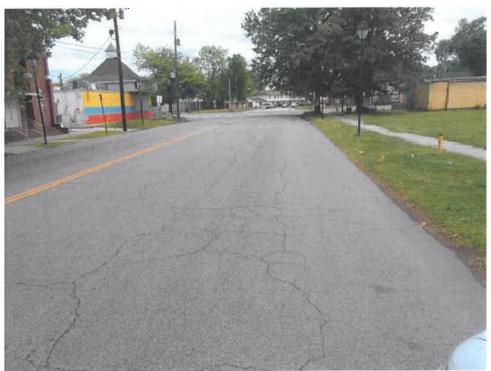
Photograph 57: Telfair Street – View facing southeast of low severity alligator cracking near East Boundary Street.

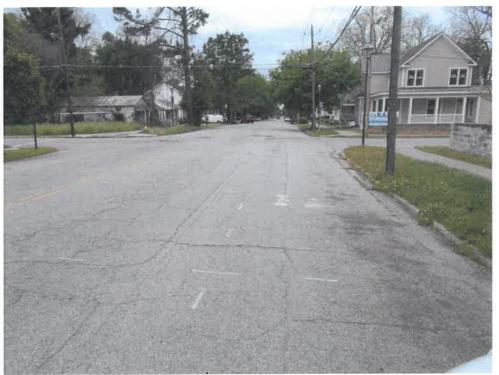
Photograph 58: Telfair Street – View facing northwest of low severity block cracking.

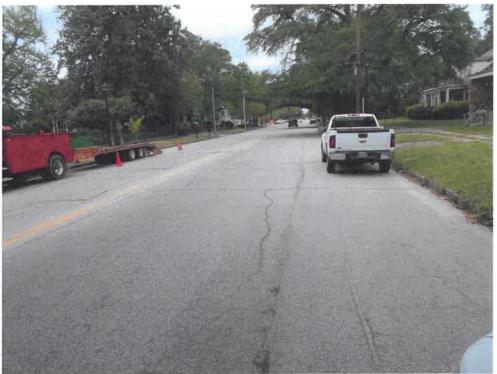
Photograph 59: Telfair Street – View facing northwest near US 1 of low severity longitudinal and transverse cracks.

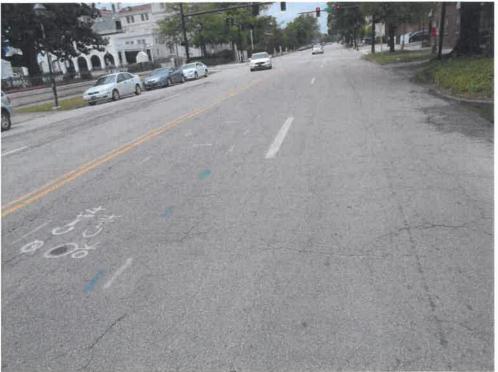
Photograph 60: Telfair Street – View facing northwest of pavement in Satisfactory condition near Core C14.

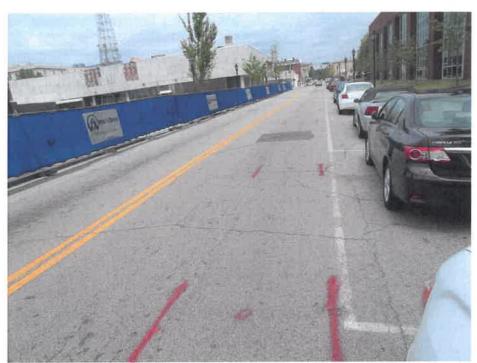
Photograph 61: 9<sup>th</sup> Street/James Brown Blvd – View facing north of low severity transverse cracking near Telfair Street intersection.

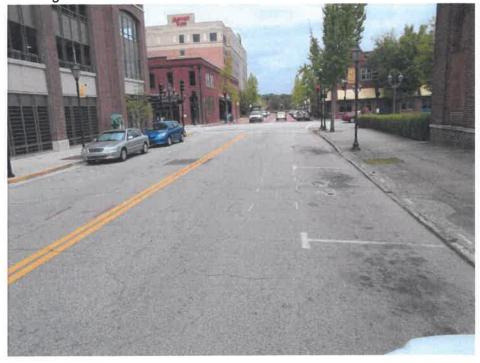
Photograph 62: 9<sup>th</sup> Street/James Brown Blvd – View facing north of pavement in Satisfactory Condition near Core C21.

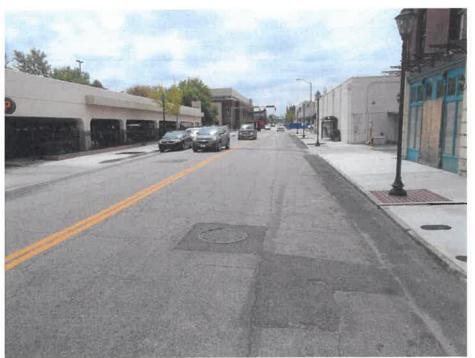
Photograph 63: 9th Street/James Brown Blvd – View facing south of low severity block cracking and medium severity patches approximately 250 north of Green Street.

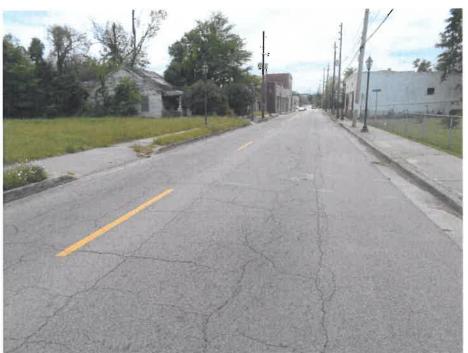
Photograph 64: 9<sup>th</sup> Street/James Brown Blvd – View facing south of low to medium severity block cracking in pavements of Fair condition near Core C24.

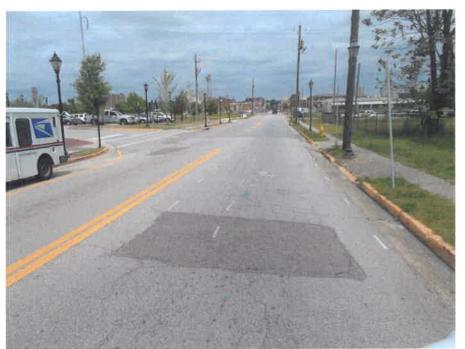
Photograph 65: 9<sup>th</sup> Street/James Brown Blvd – View facing north of medium severity patch and medium severity alligator cracking Core C23.

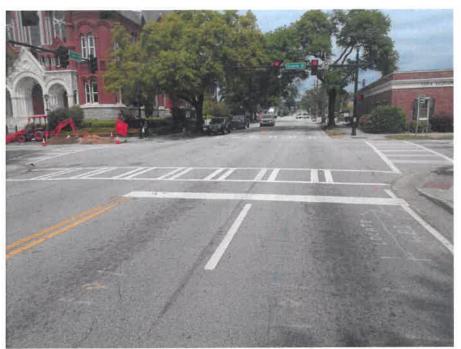
Photograph 66: 13<sup>th</sup> Street – View facing north of pavement in Good condition at intersection with Green Street.

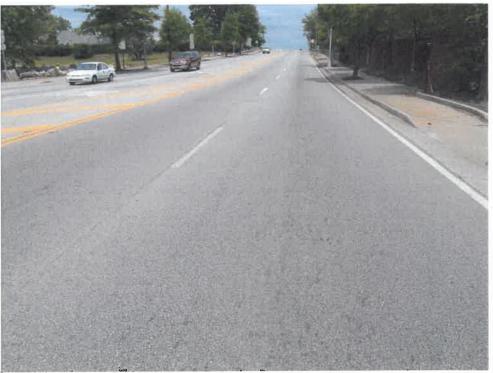
Photograph 67: 13th Street – View facing north of pavement in Good condition near Core C17.

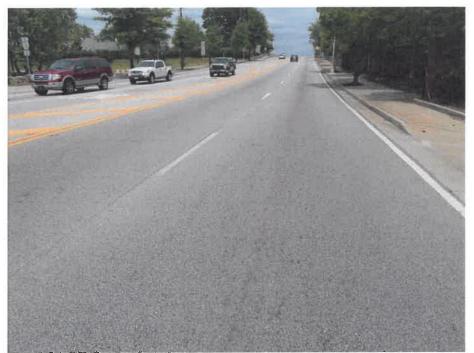
Photograph 68: 13<sup>th</sup> Street – View facing north of pavement in Good condition near intersection of Broad Street.

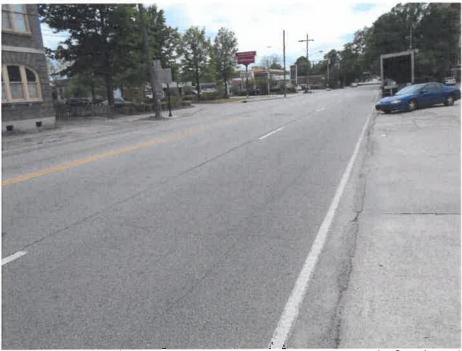
Photograph 69: 13th Street - View facing south of pavement in Good condition near Core C19.

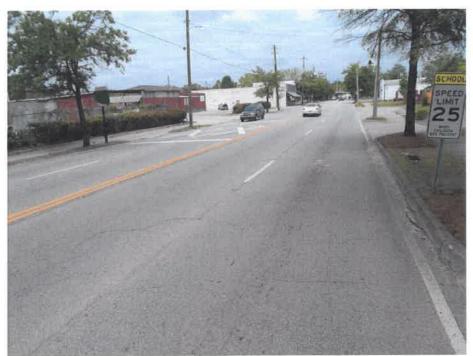
Photograph 70: 13th Street – View facing north of low severity transverse cracks near Core C19.

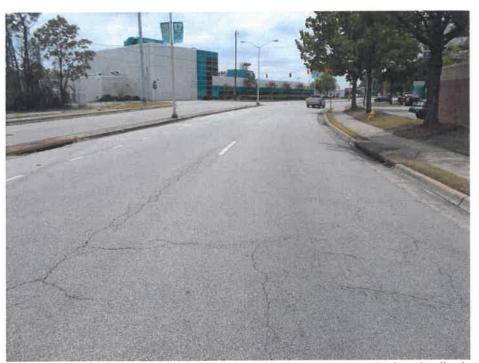
Photograph 71: 13<sup>th</sup> Street – View facing south of low severity longitudinal and transverse cracking along with shallow rutting in right wheel lane near Core C20. Pavement in Satisfactory condition.

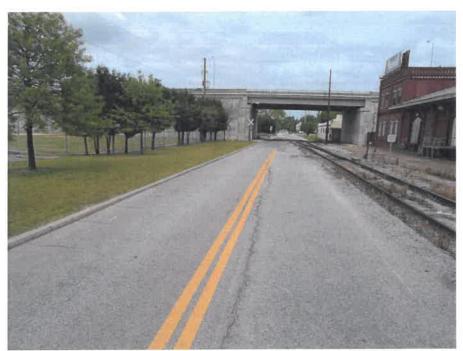
Photograph 72: 6<sup>th</sup> Street – View facing north of medium severity joint crack and medium severity weathering near Taylor Street. Pavement in Fair condition.

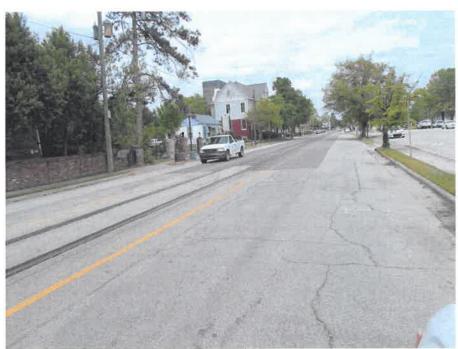
Photograph 73: 6<sup>th</sup> Street – View facing north of medium severity longitudinal cracking near Telfair Street.

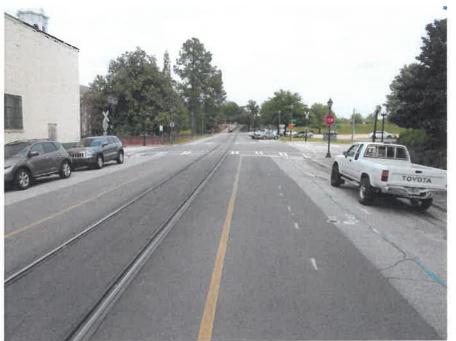
Photograph 74: 6<sup>th</sup> Street – View facing north near of low severity longitudinal cracking near Core C25.

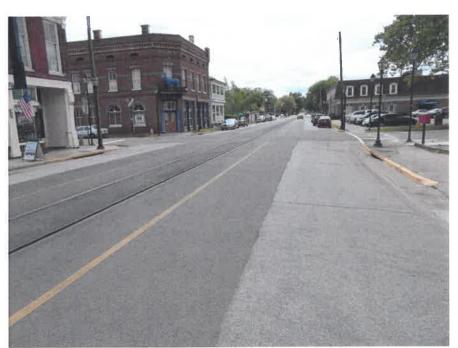
Photograph 75: 6<sup>th</sup> Street – View facing south of pavement in Satisfactory condition near intersection of Ellis Street.

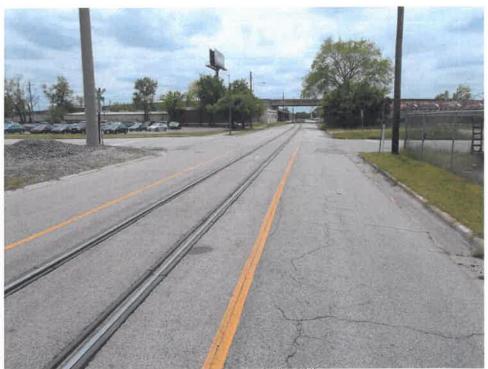
Photograph 76: 6th Street – View facing south of medium severity longitudinal cracking near Core C26.

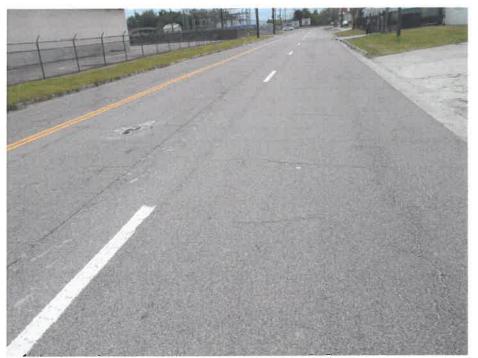
Photograph 77: 5<sup>th</sup> Street – View facing south of medium severity weathering and low severity longitudinal cracking near Core C30.

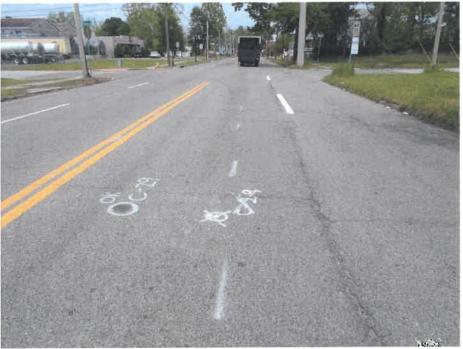
Photograph 78: 5<sup>th</sup> Street – View facing north of medium severity joint cracking near Core C29 looking north.

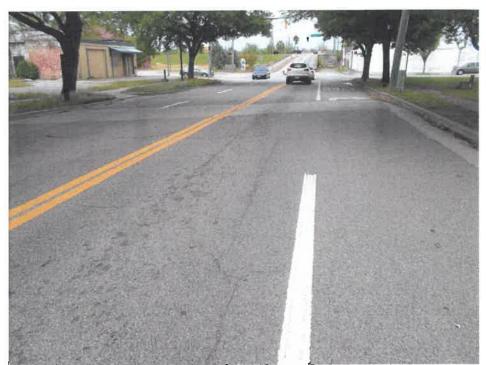
Photograph 79: 5<sup>th</sup> Street – View facing north of pavement in Satisfactory condition near intersection of Reynolds Street.

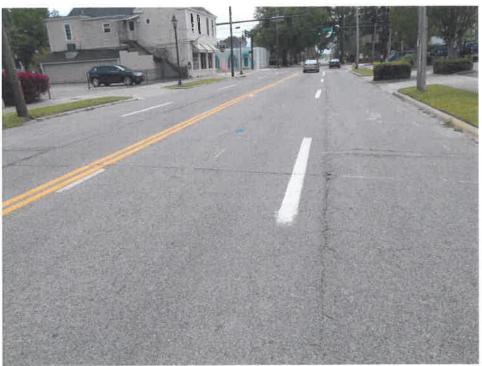
Photograph 80: 5<sup>th</sup> Street – View facing south of medium severity joint cracking near Core C28.

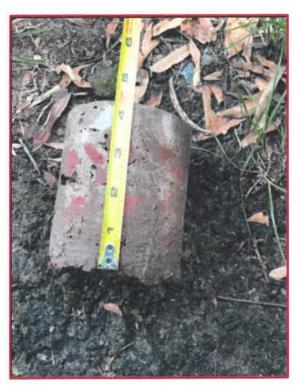
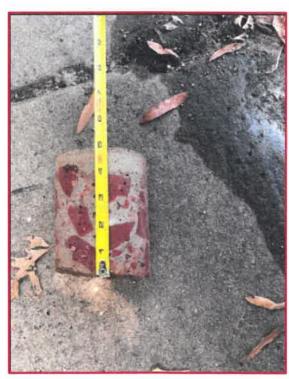
Figure 4: Concrete Cores @ B1 and B2

The drilled surfaces at the subject site are covered with the existing concrete sidewalk and asphalt pavement. The concrete sidewalk was measured at 4 & 5 inches thick at borings B1 and B2, respectively. The cored concrete appeared to have broken brick as aggregate.

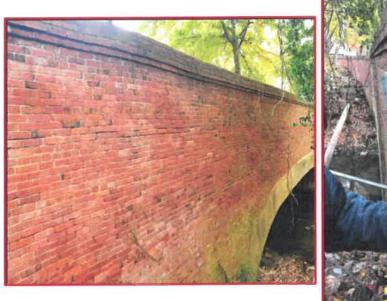
Figure 5: (L) View of Wing and Spandrel Walls along Western Side. (R) Measuring Degree of Tilt

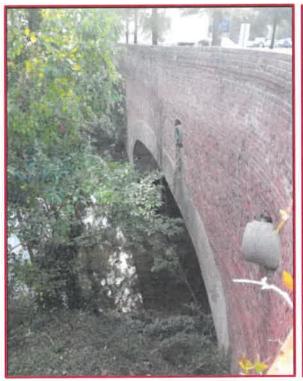
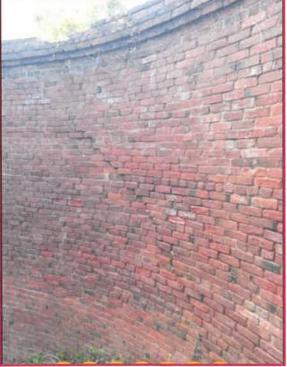
- The Existing Parapet Walls on both the East and West sides of the bridge consist of unreinforced Brick with Mortar joints, exhibiting several vertical cracks.
- East Wingwall (South End) is inclined (out of plumb) in an easterly direction. Based on our measurements, the degree of tilt was estimated to be on the order of 8° to 9° from vertical.
- East Curved Wingwall (North End) exhibited a diagonal crack, likely due to differential settlement of wall foundation. The degree of tilt was estimated to be on the order of 3° from vertical.
- West Wingwall (South End) is inclined (out of plumb) in a westerly direction. The degree of tilt was estimated to be on the order of 2° from vertical.
- West Curved Wingwall (North End) exhibited some vertical cracks within the parapet section of the wall and no observable tilt within the wing wall.

Figure 6: (L) View of Wing and Spandrel Walls along Eastern Side. (R) Diagonal Crack in Brick Wingwall at North End of Eastern Wall.

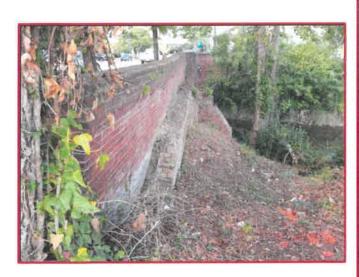
Figure 7: (L) View of Wall Along Eastern Side where Tilt is Visible. (R) Vertical Crack and Separation of Parapet Wall on Eastern Side
